**The Monadnock Building**  
Chicago, Illinois

# Tech Notes

## HISTORIC INTERIOR SPACES

#### Preserving Historic Office Building Corridors

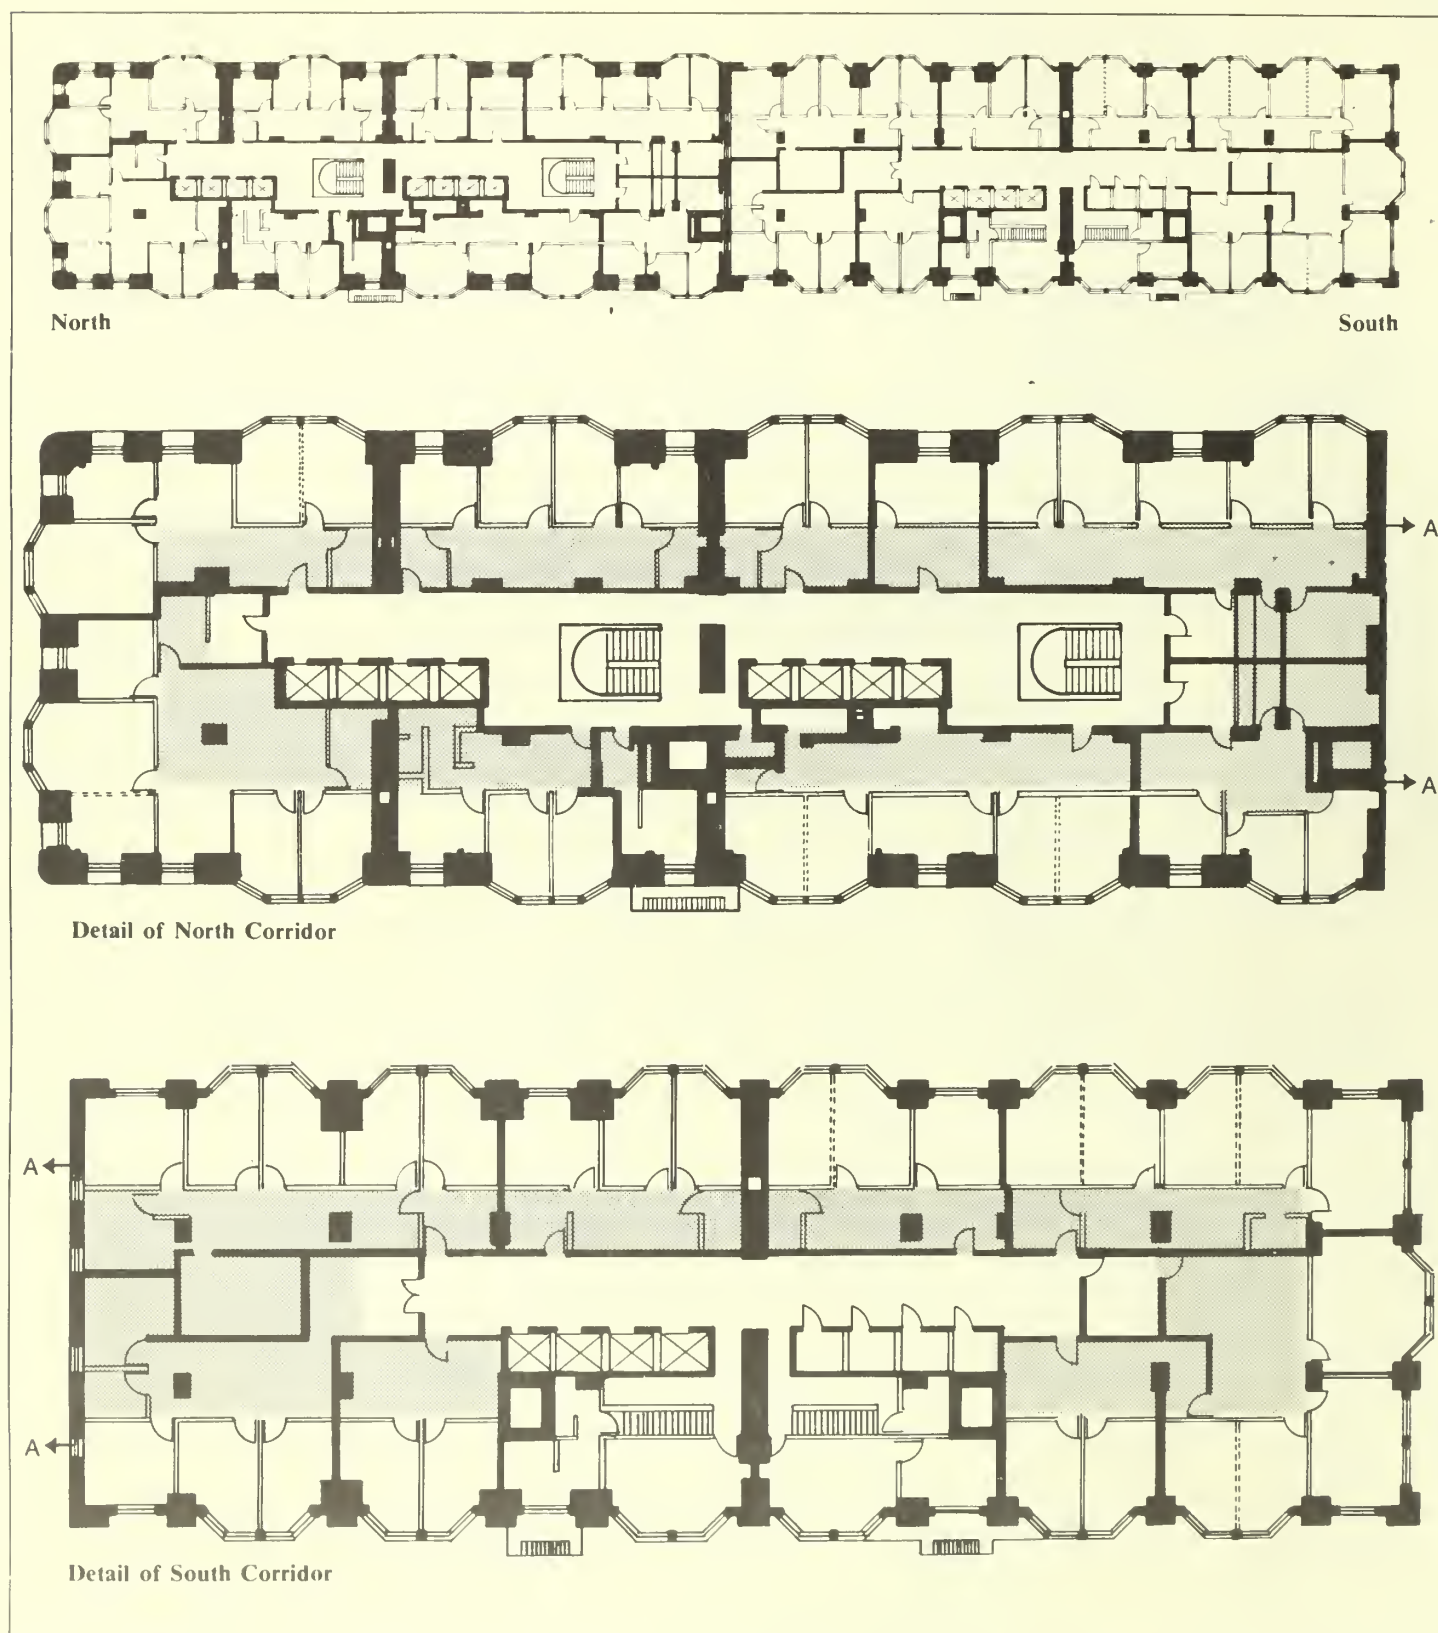
Figure 1. Both north and south building floor plan, showing double-loaded corridor system. Shaded area indicates dropped ceiling for mechanical chases in the non-public anterooms. Public corridors and private offices retain full ceiling height. Drawing: Neal Vogel

Typically, the ceilings in office building corridors are dropped to allow for mechanical chases to run longitudinally through the building. Retention of the Monadnock's historic plaster ceilings in the corridors was possible by locating mechanical systems above dropped ceilings in the non-public space adjacent to the corridors. These secretarial anterooms are located between the corridors and private office bays (See figures 1, 3, and 4).

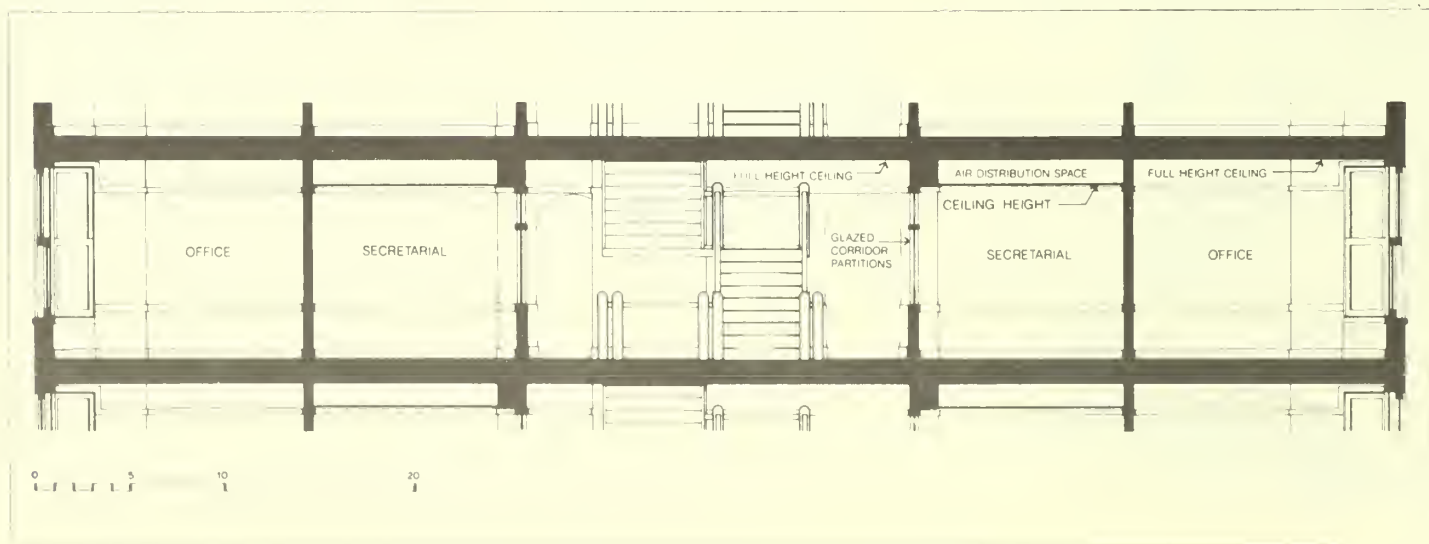
Figure 3. Building cross section showing open stairs and full height ceilings in corridors and private offices. Glazed corridor partitions are feather-chipped glass. Drawing: Montauk Company

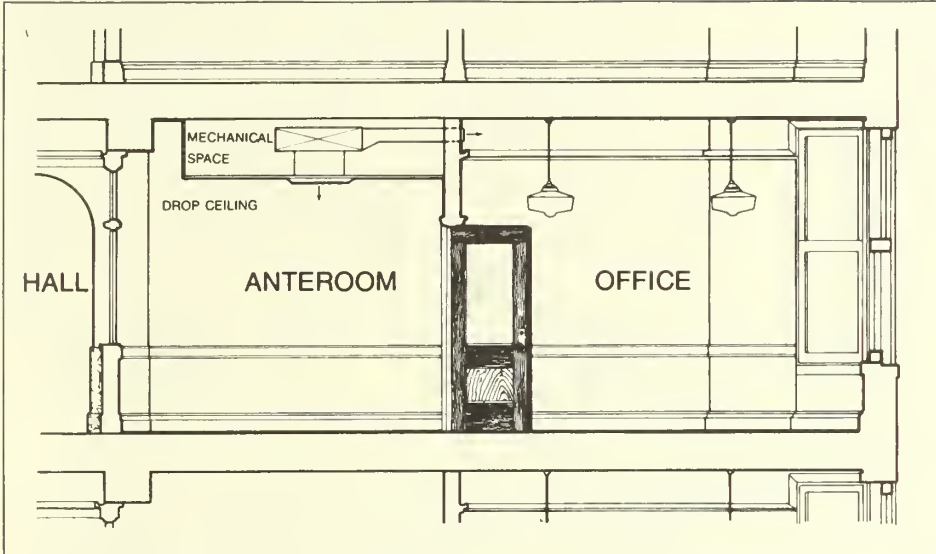
**Figure 4.** The innovative rehabilitation solution places dropped ceilings only in the anteroom, thus preserving the important historic features in the public corridors and private office spaces. The dropped ceiling area is large enough for future expansion of mechanical and electrical systems. Drawing: Neal Vogel

100-foot intervals. Each office suite is then serviced by individual heat pumps connected to a riser on each floor. Duct work to supply the conditioned air is concealed by the dropped ceilings in the anterooms.
